STANLEY FASTENING SYSTEMS ENGINEERING LABORATORY

Test Lab No.: 08815-00

Forensic Evaluation of N79WW-1 0356 047

Examine and evaluate N79 WW, tool allegedly involved in an accident with injury to Jonathan Beijar

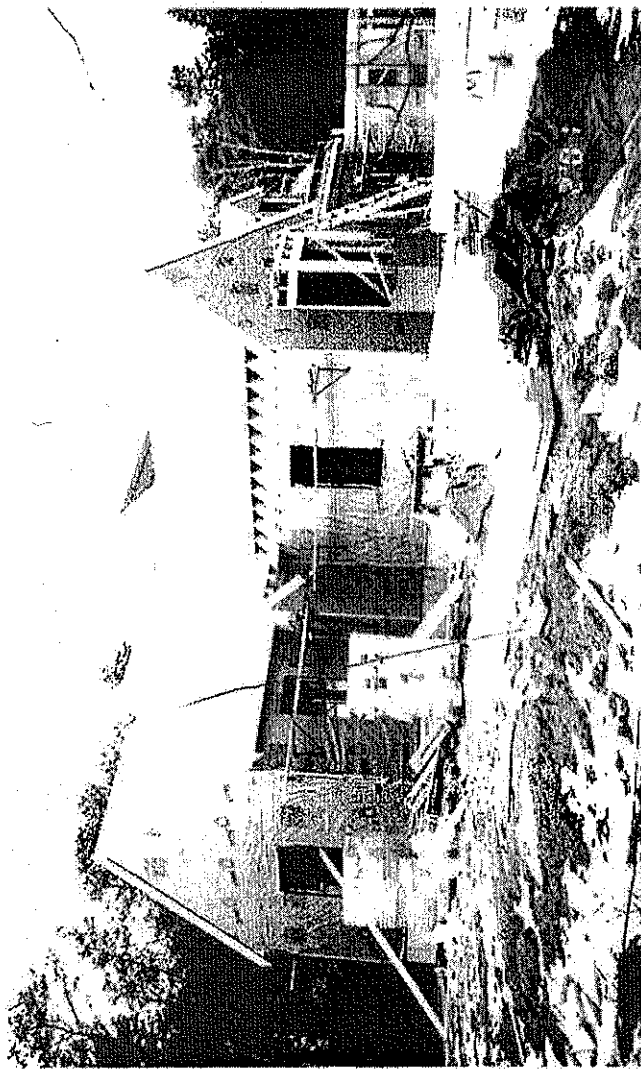
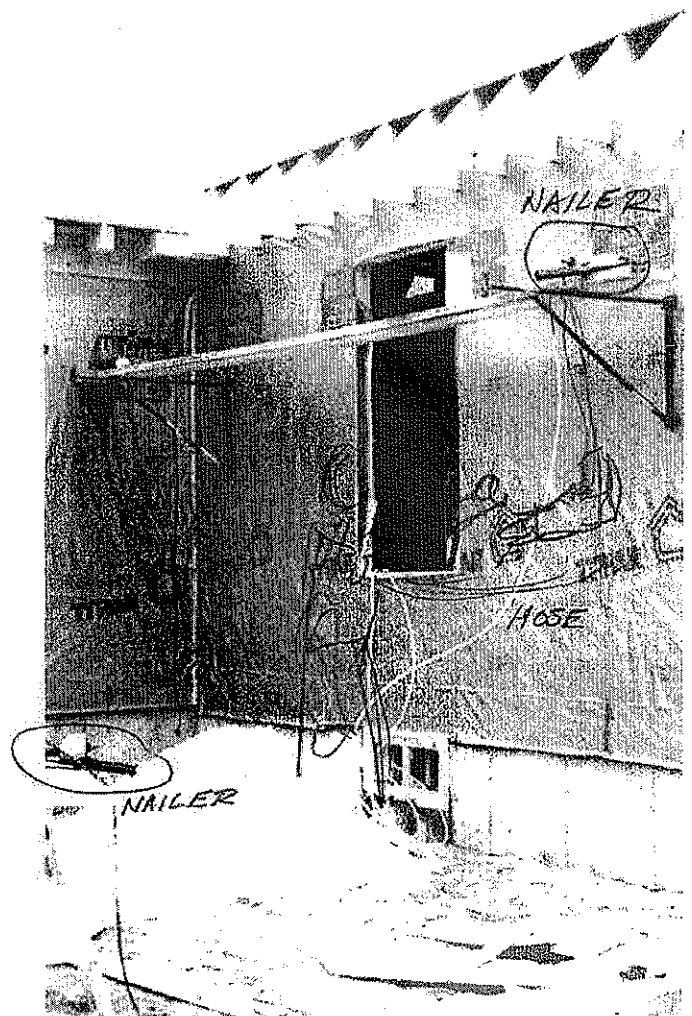
TOOL SWINGS DOWN ON HOSE
HE GRABS HOSE ABOVE COMN.
TOOL KEEPS TOWARDS CHEST
FOR ARM/ELBOW HIT TRIGGER
BUT CANNOT PREVENT CHEST
IMPACT

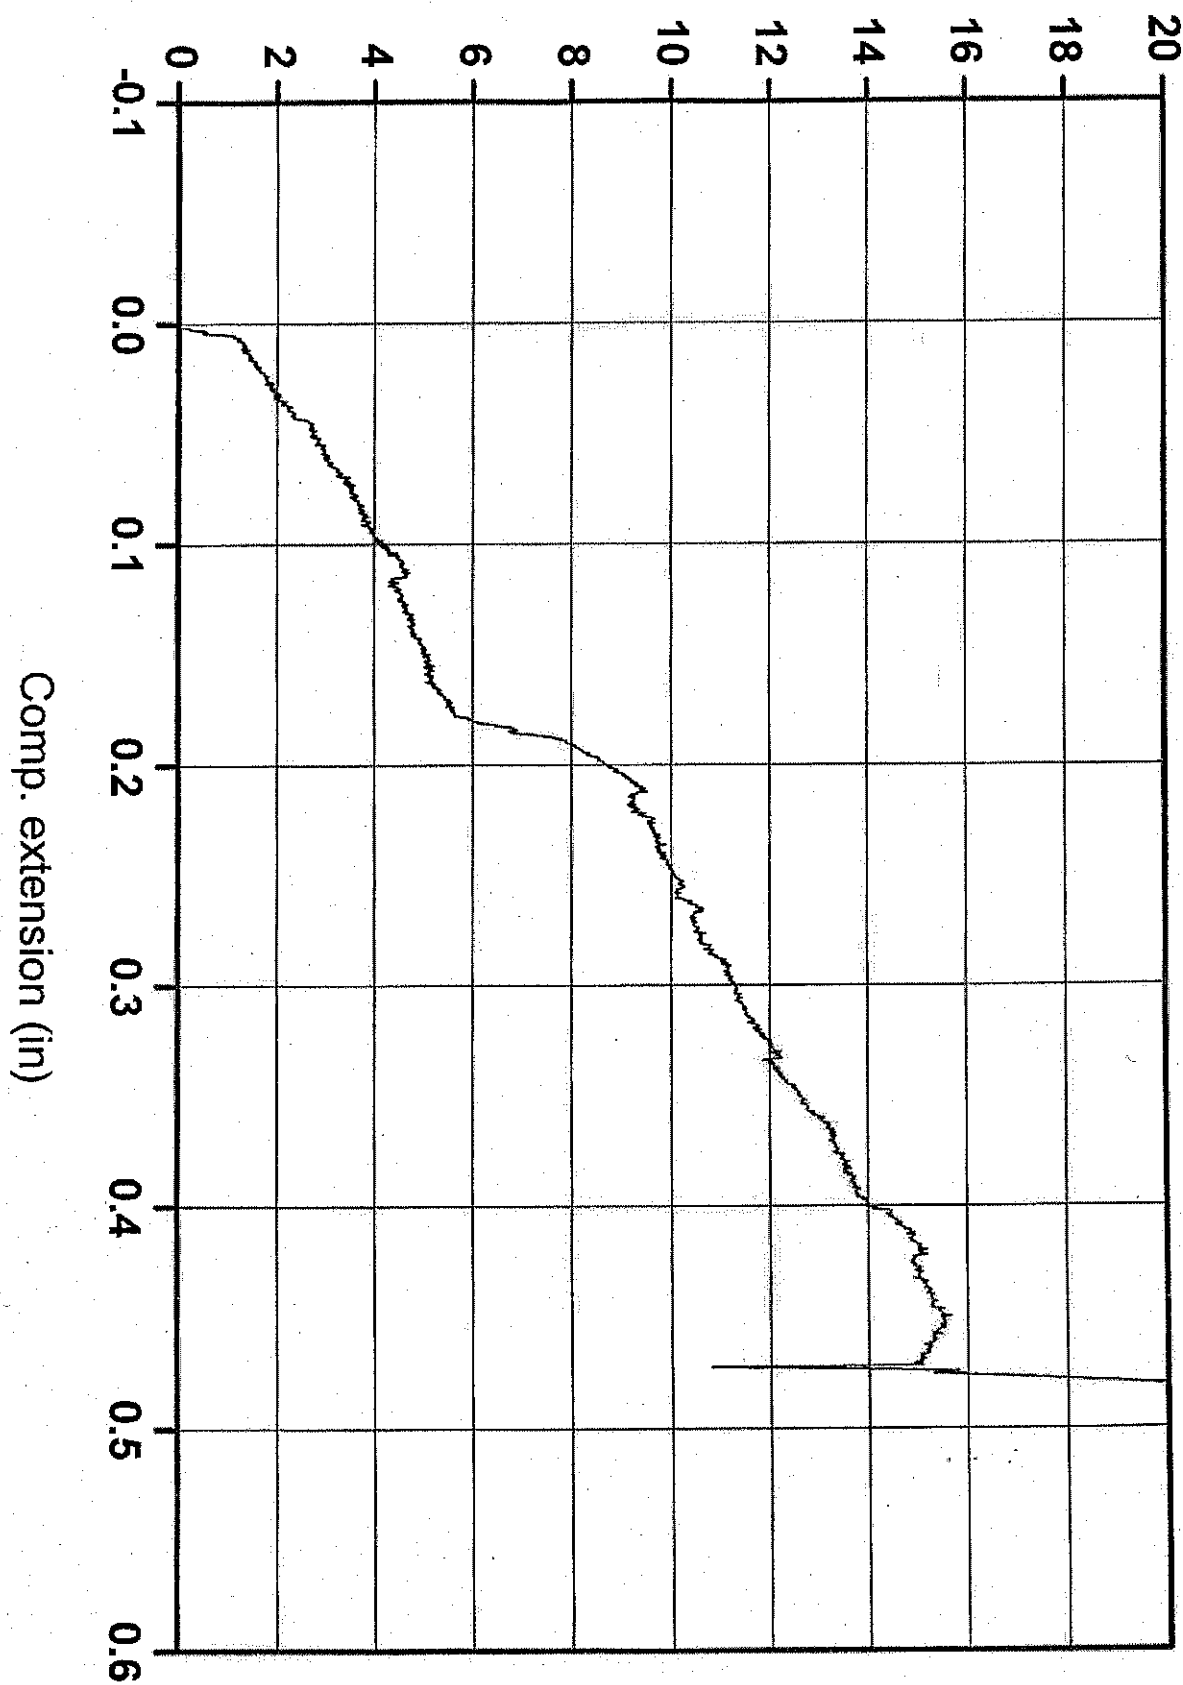
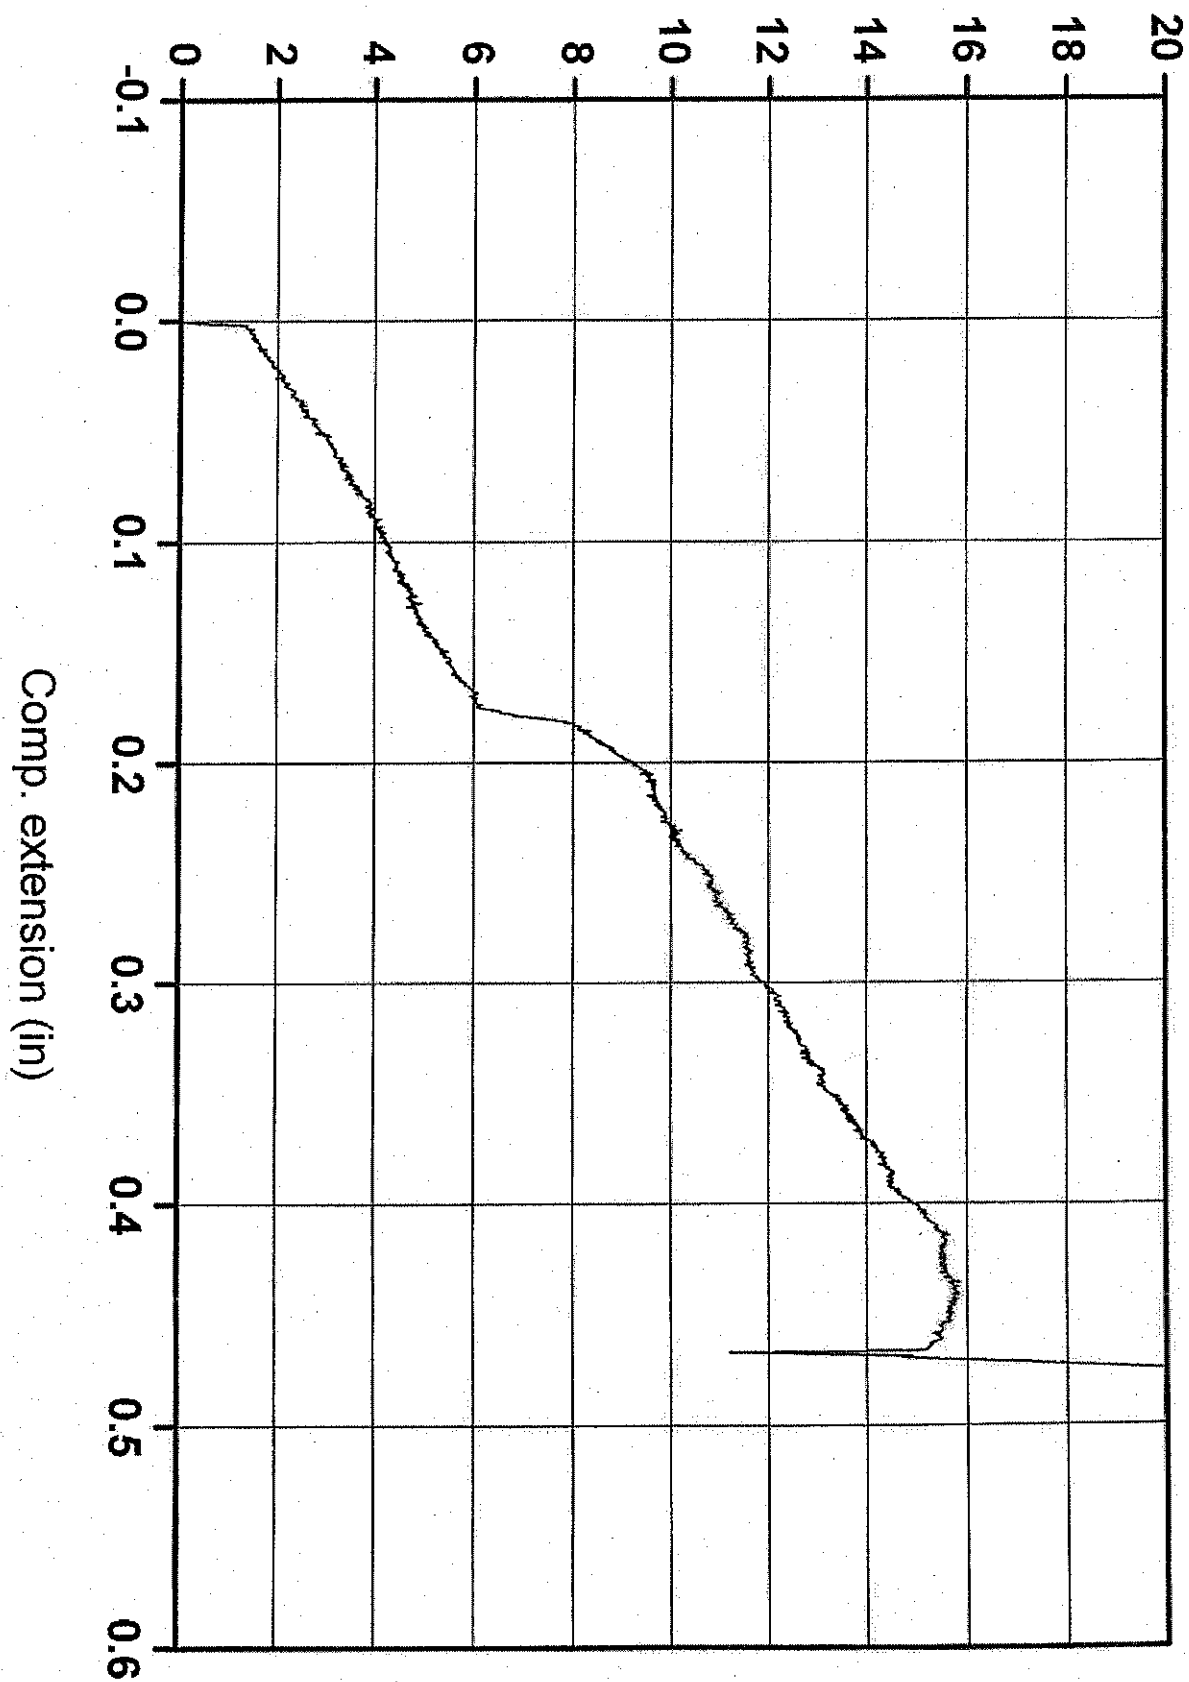
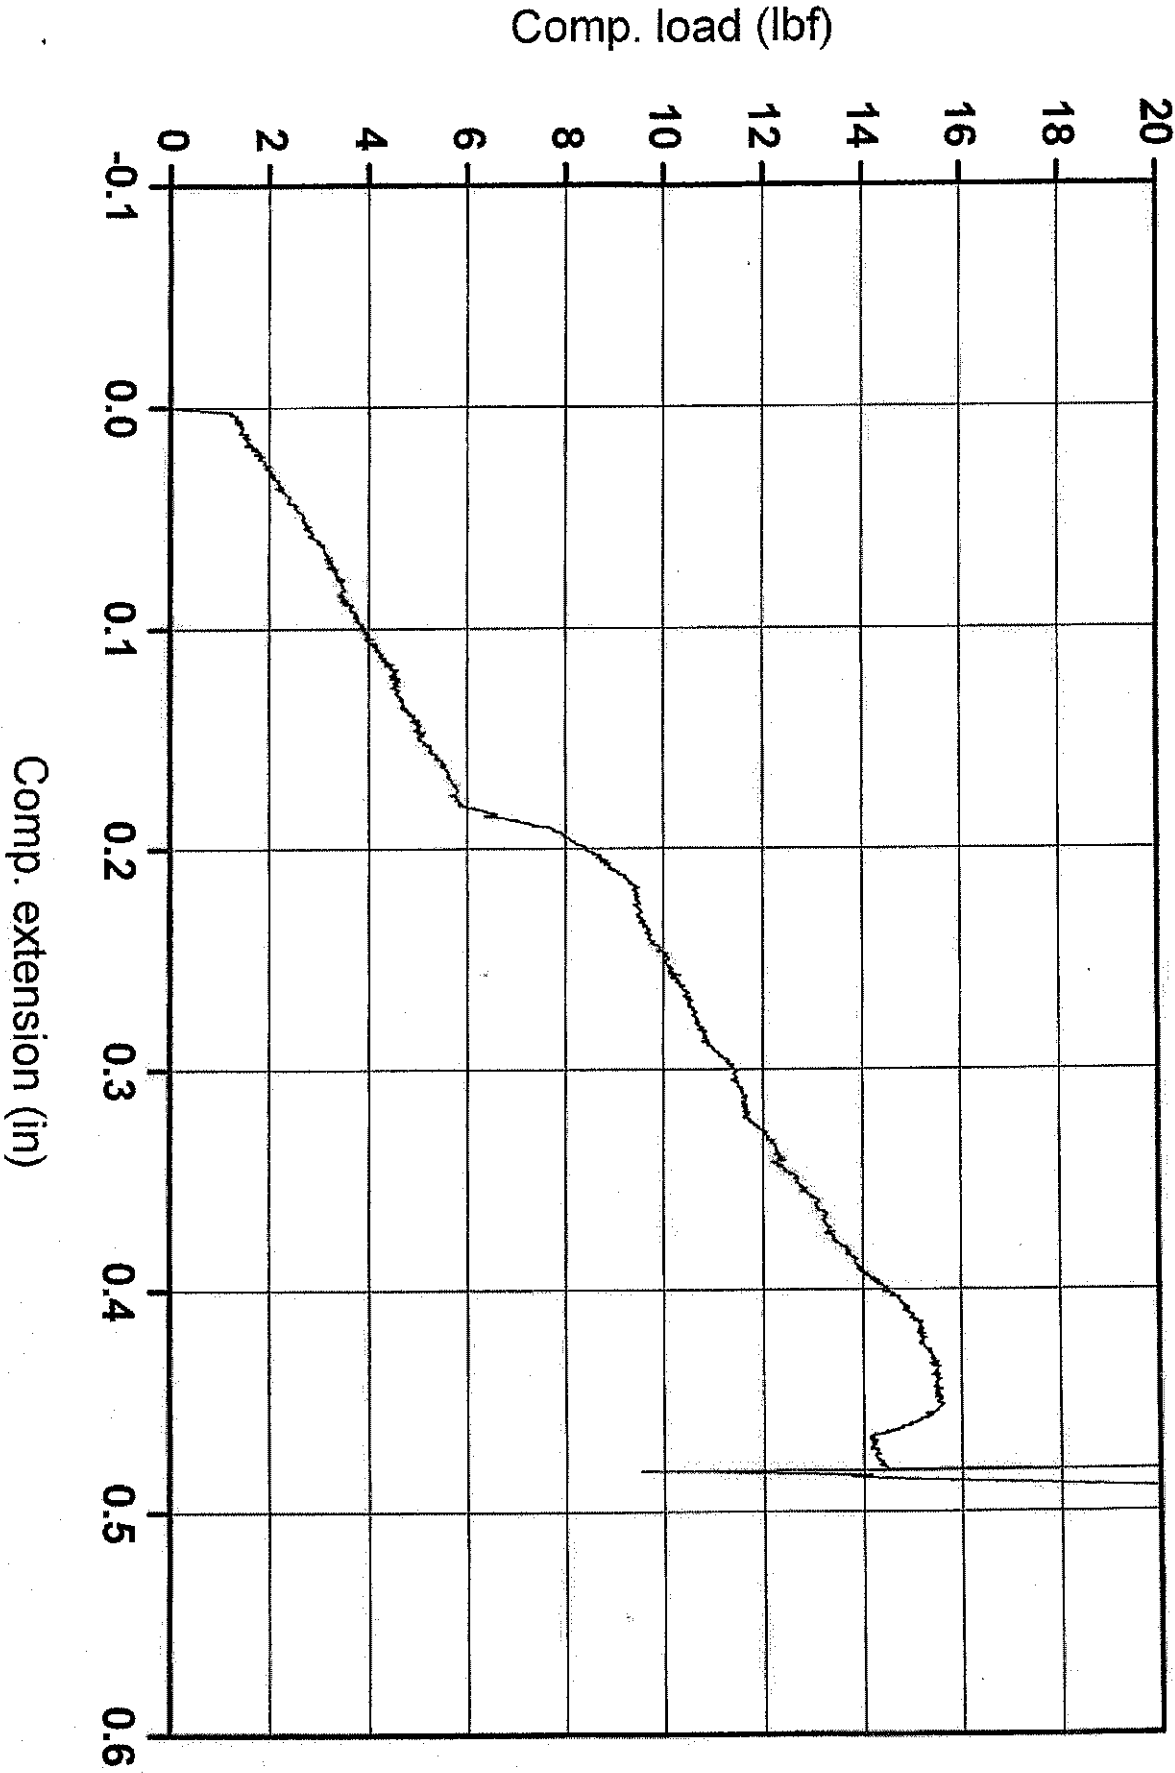
- 1) Tool Weight (fully loaded with the largest specified fasteners) = 9.037lbs.
- 2) Largest specified fasteners: **S16D131**
- 3) Contact trip force required for actuation with 100 psig applied to the tool = **14.843lbf. (average of 3 tests)**
- 4) Contact trip travel until actuation occurs = **.473" (average of 3 tests)**
- 5) With the tool upright by its own weight (fully loaded), exercising the trigger mechanism did not cause the tool to actuate with 60 to 100 psig applied.
- 6) Contact trip force and trip travel measurement data is attached.

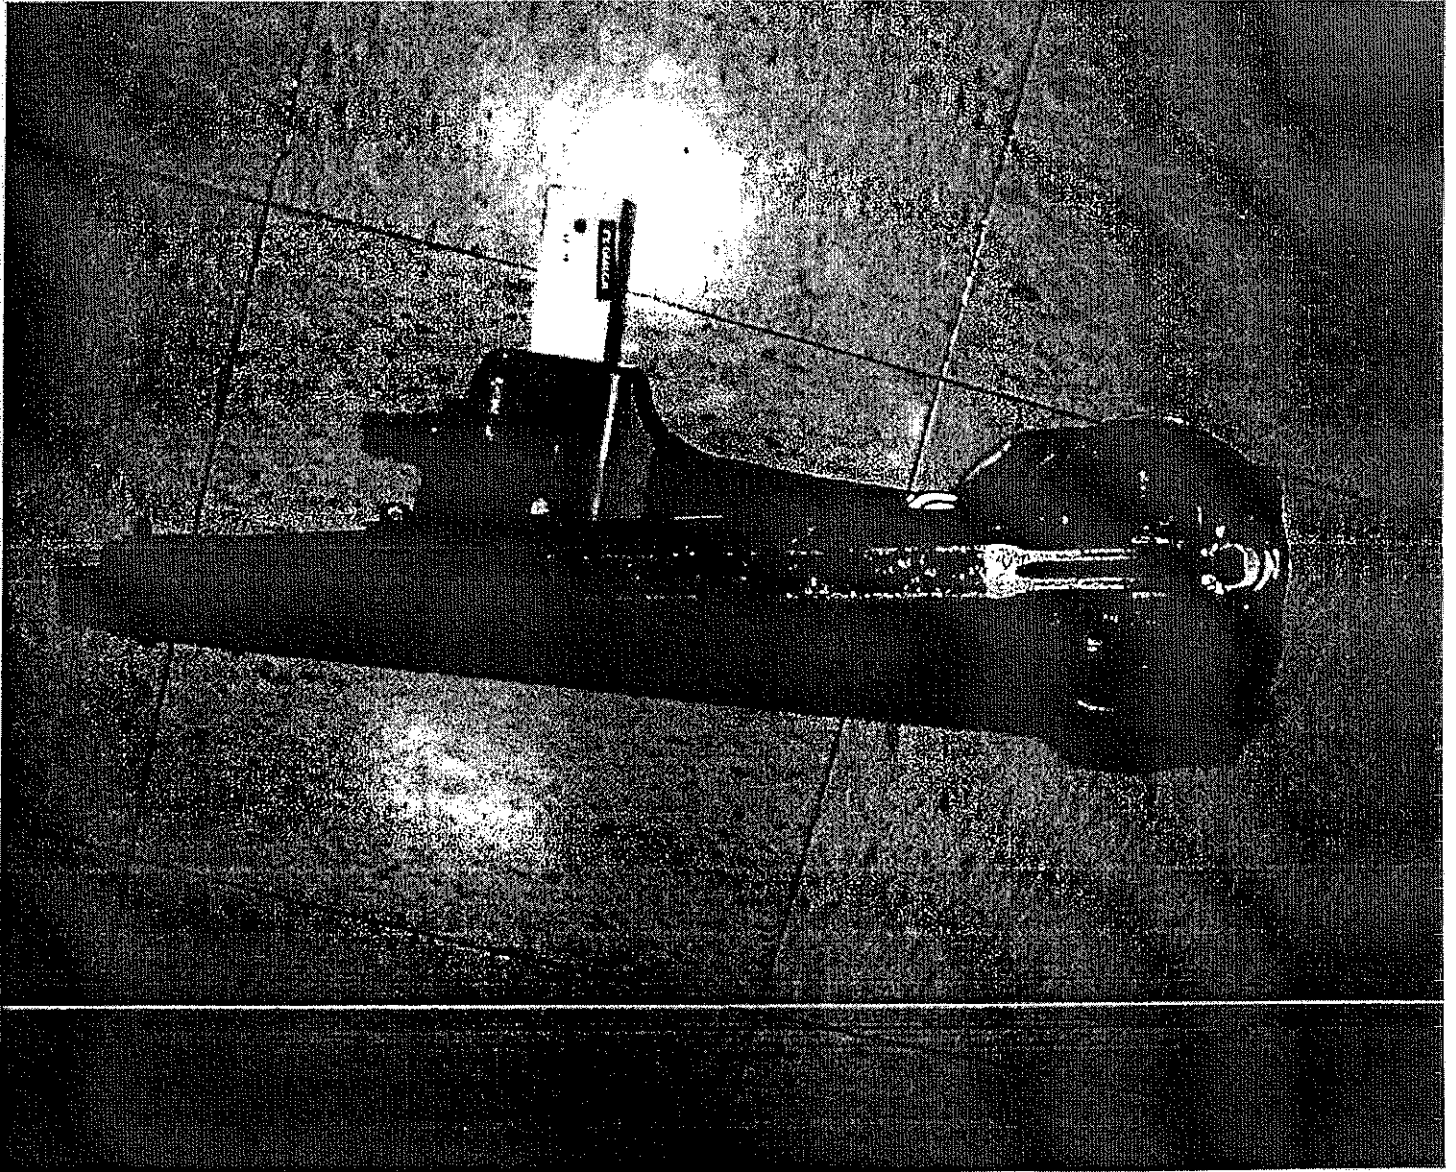
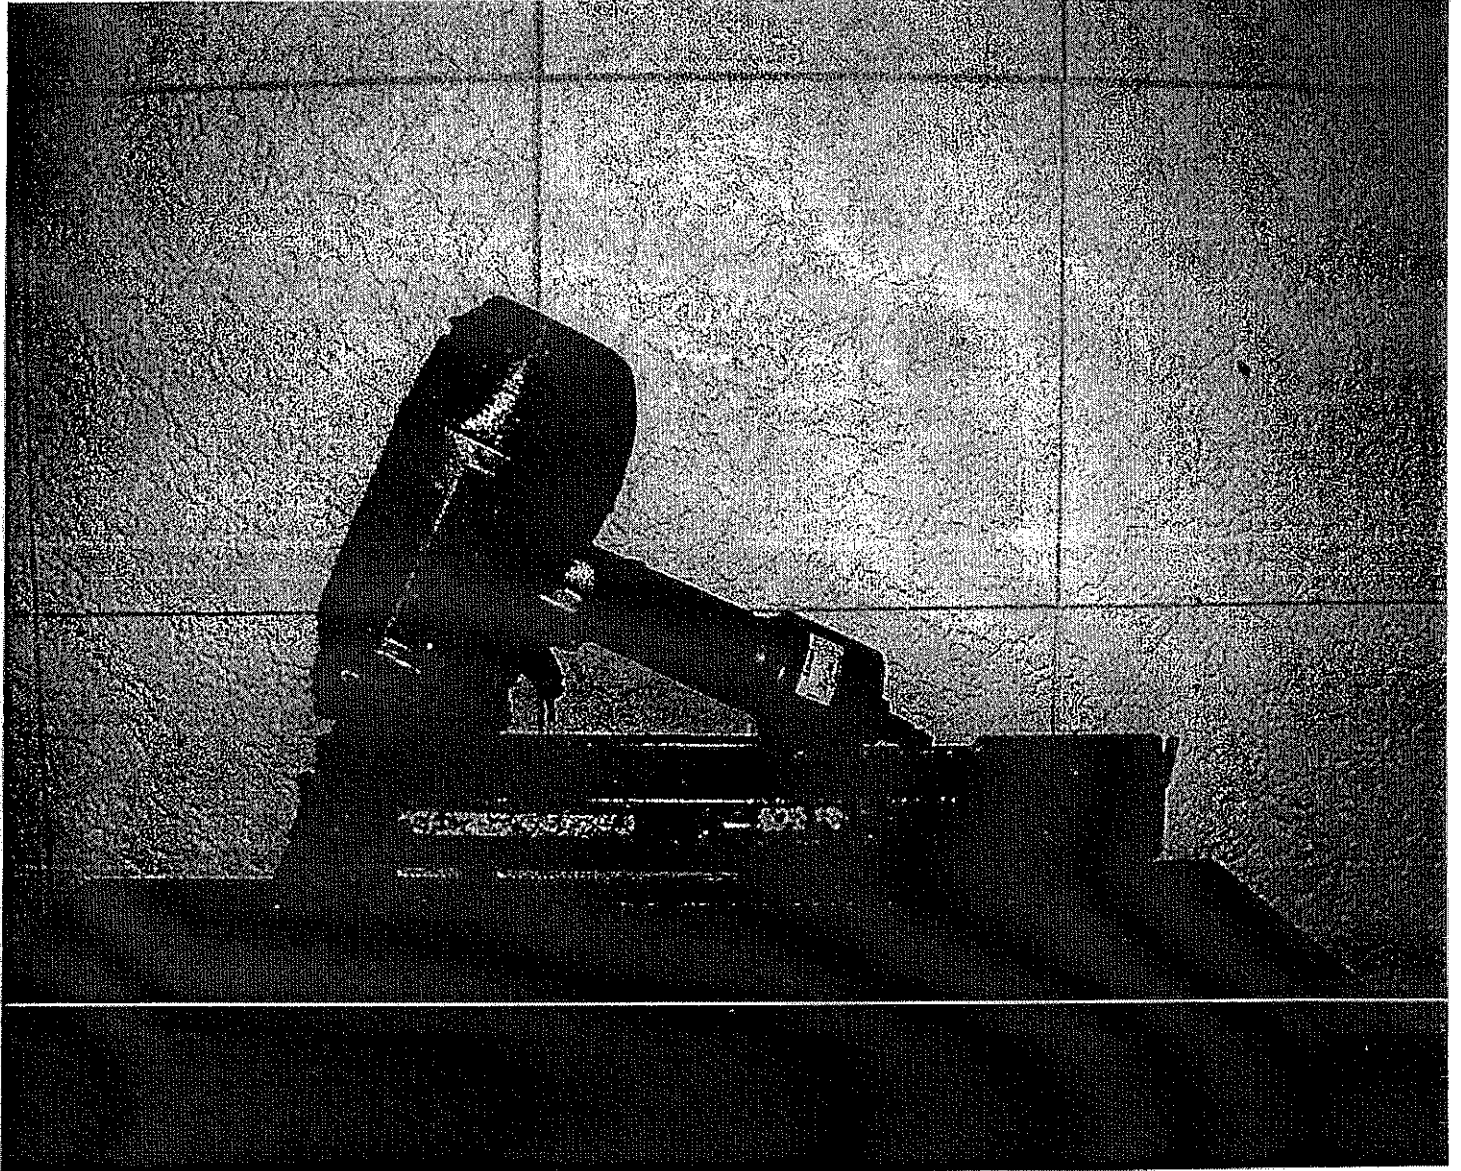
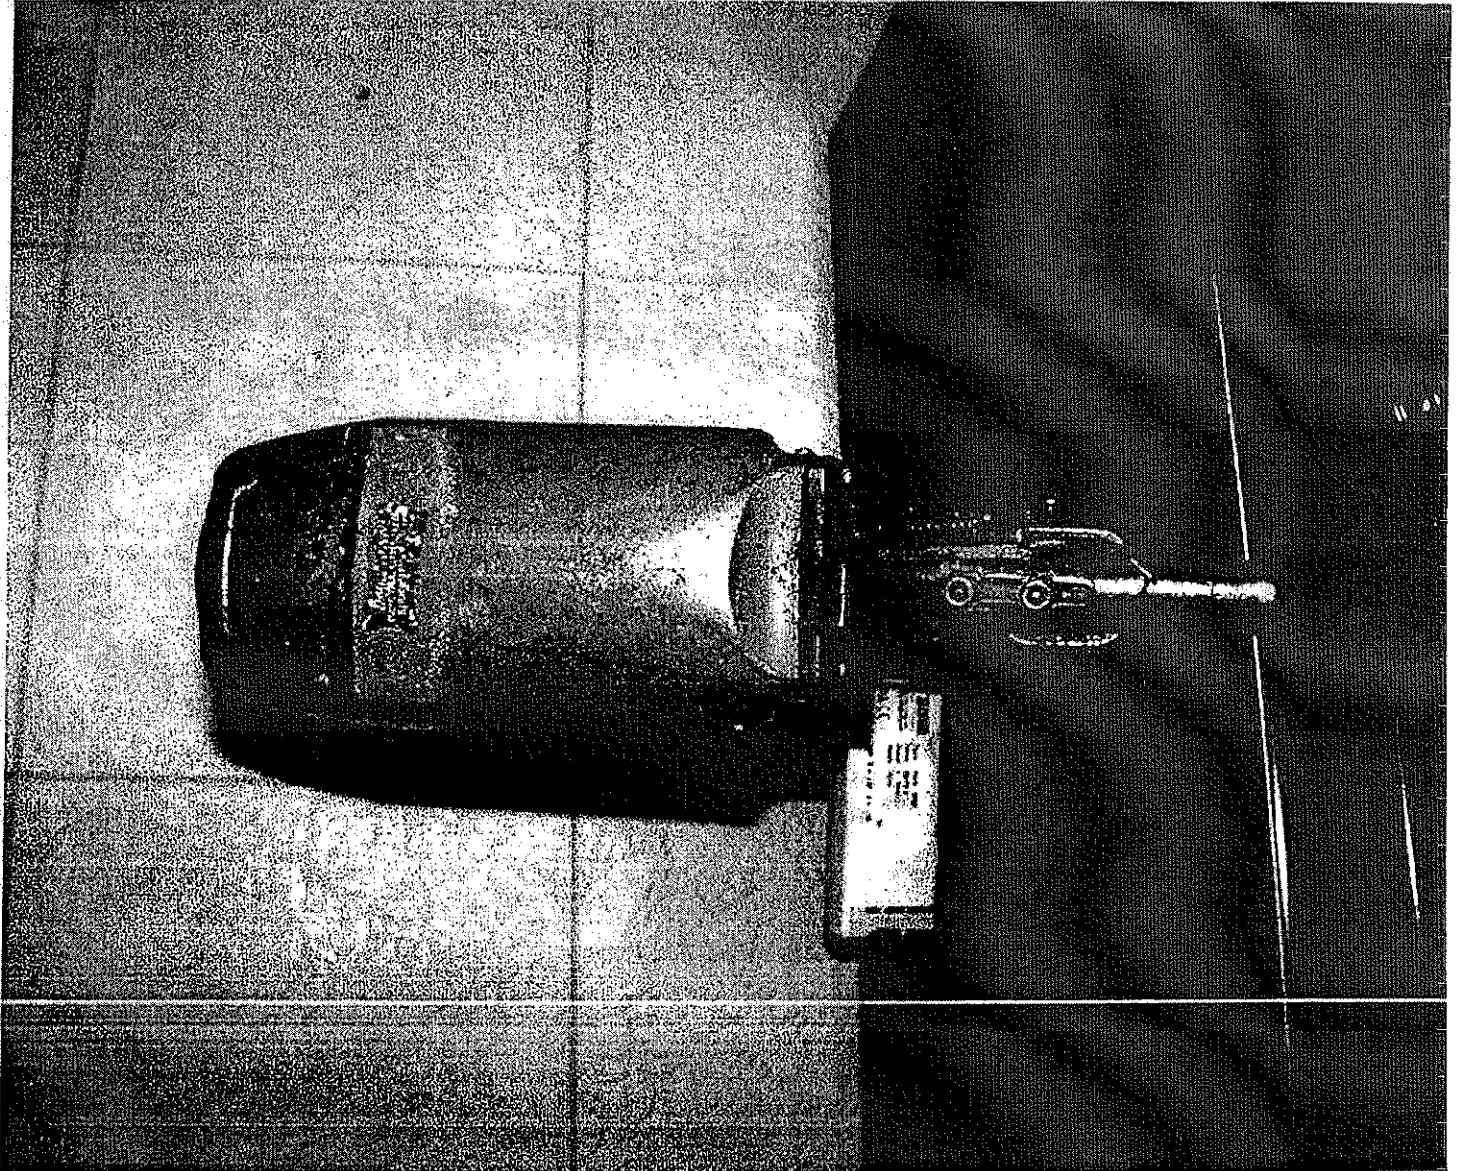
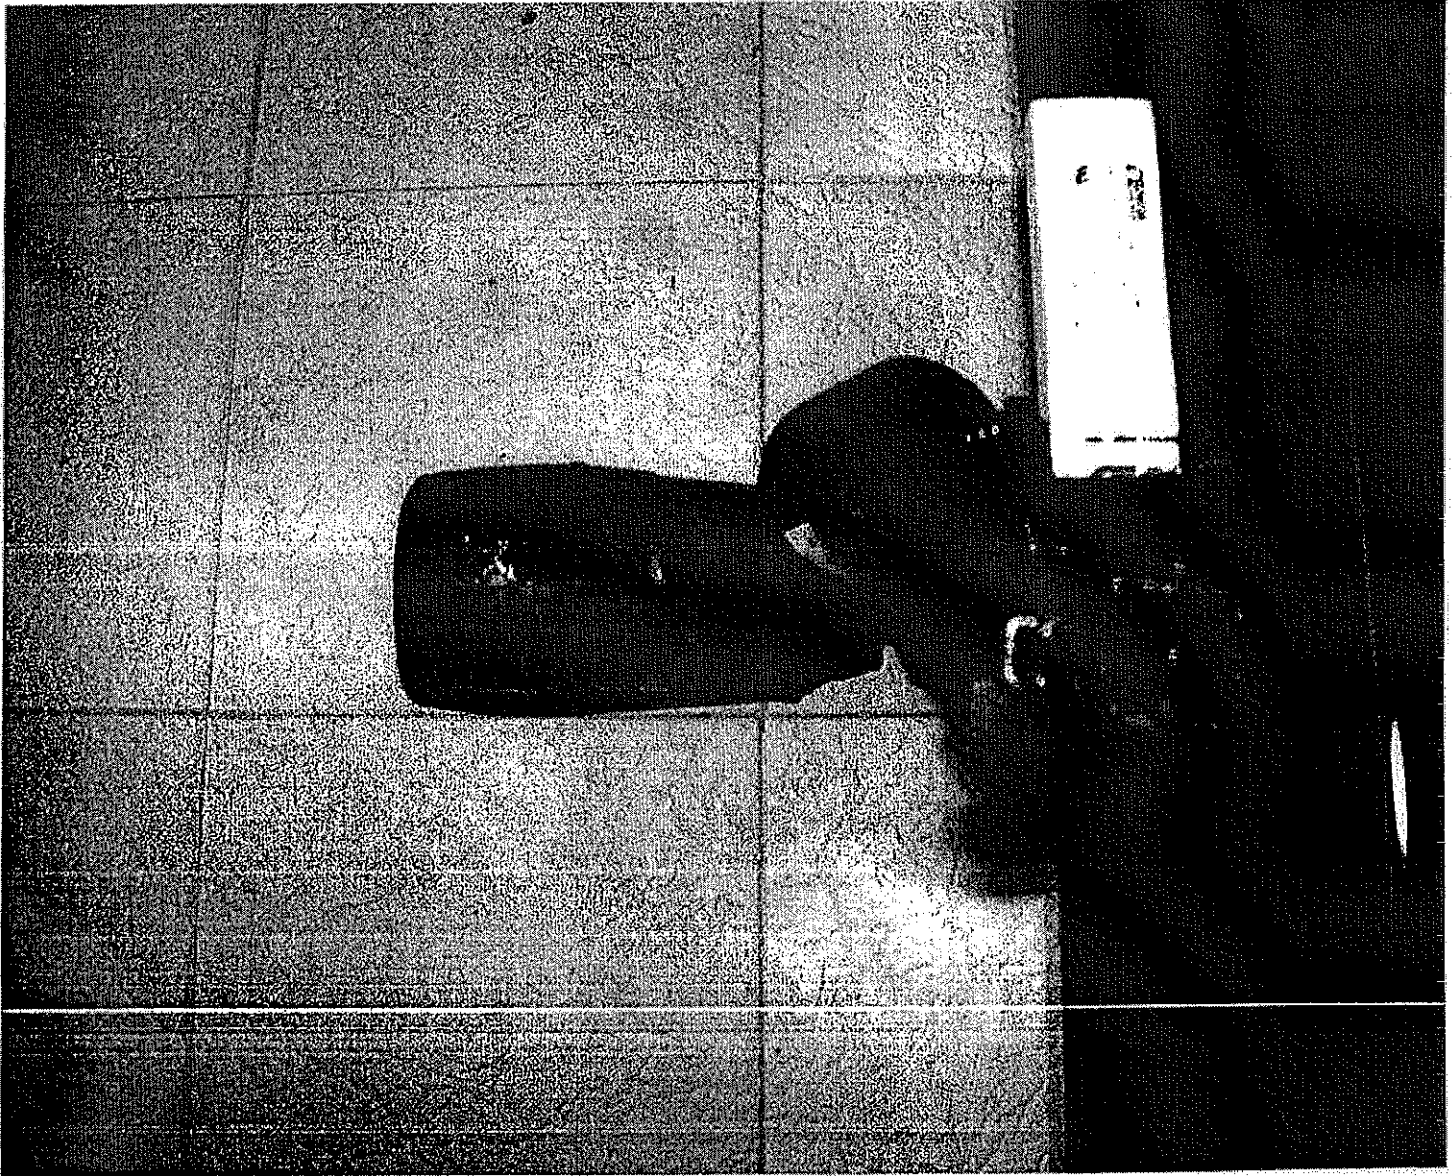
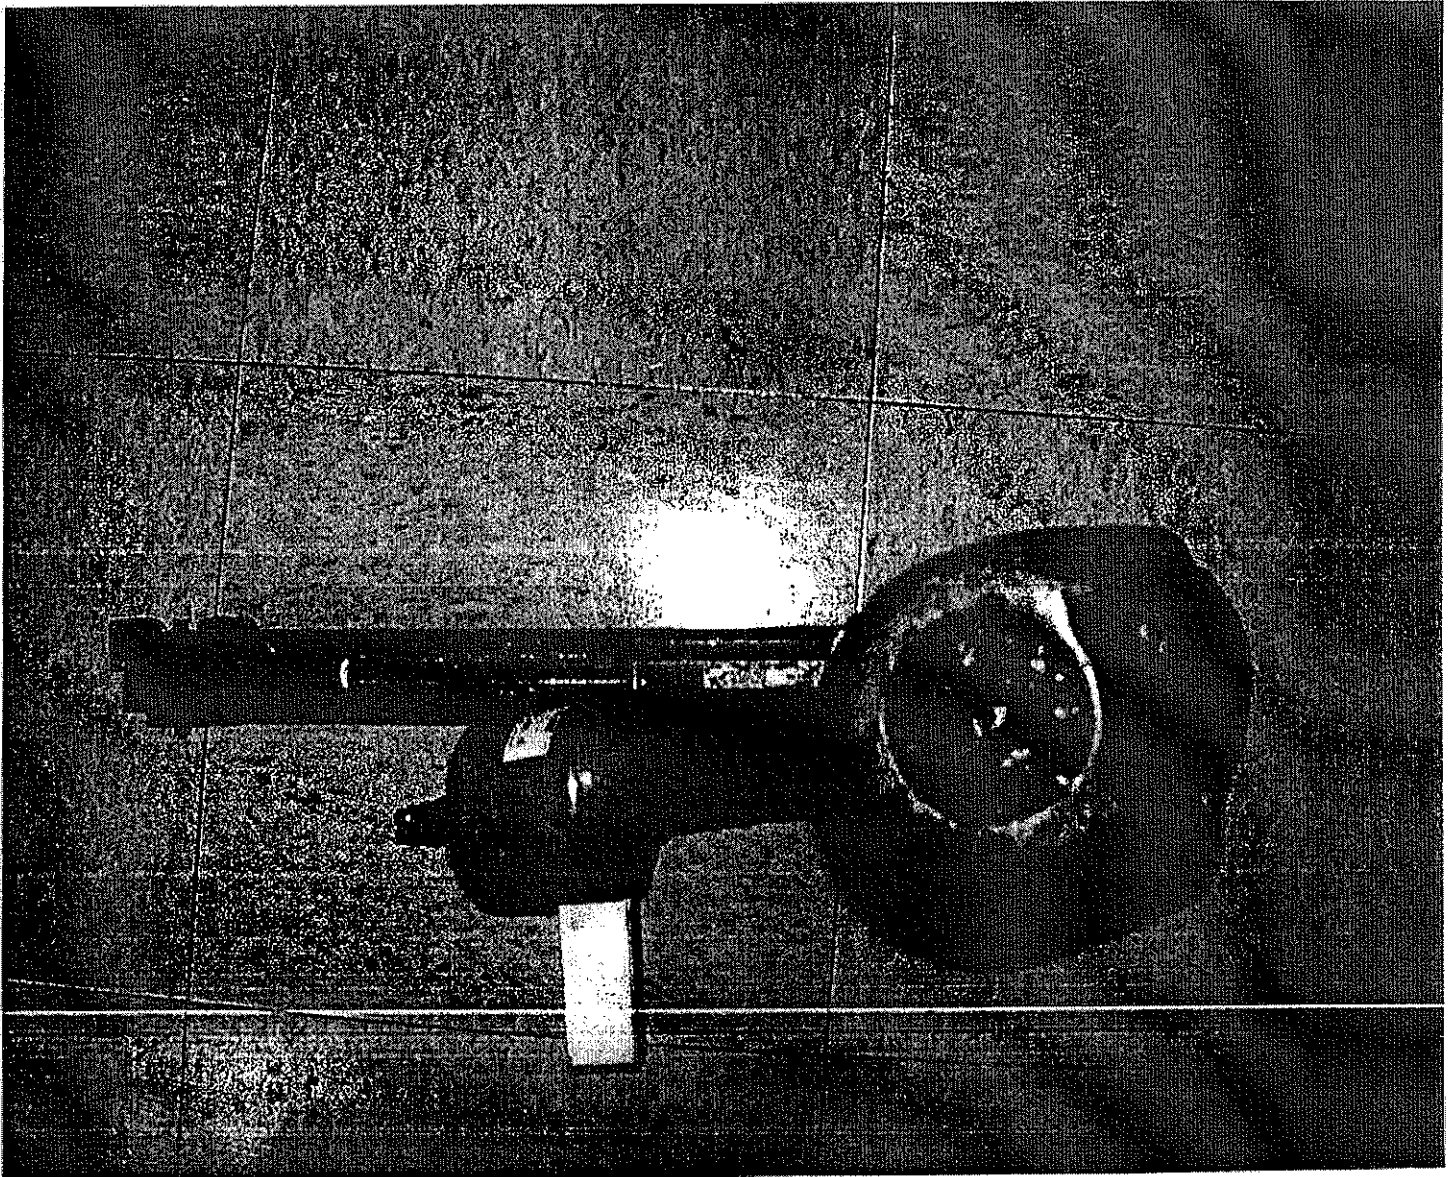
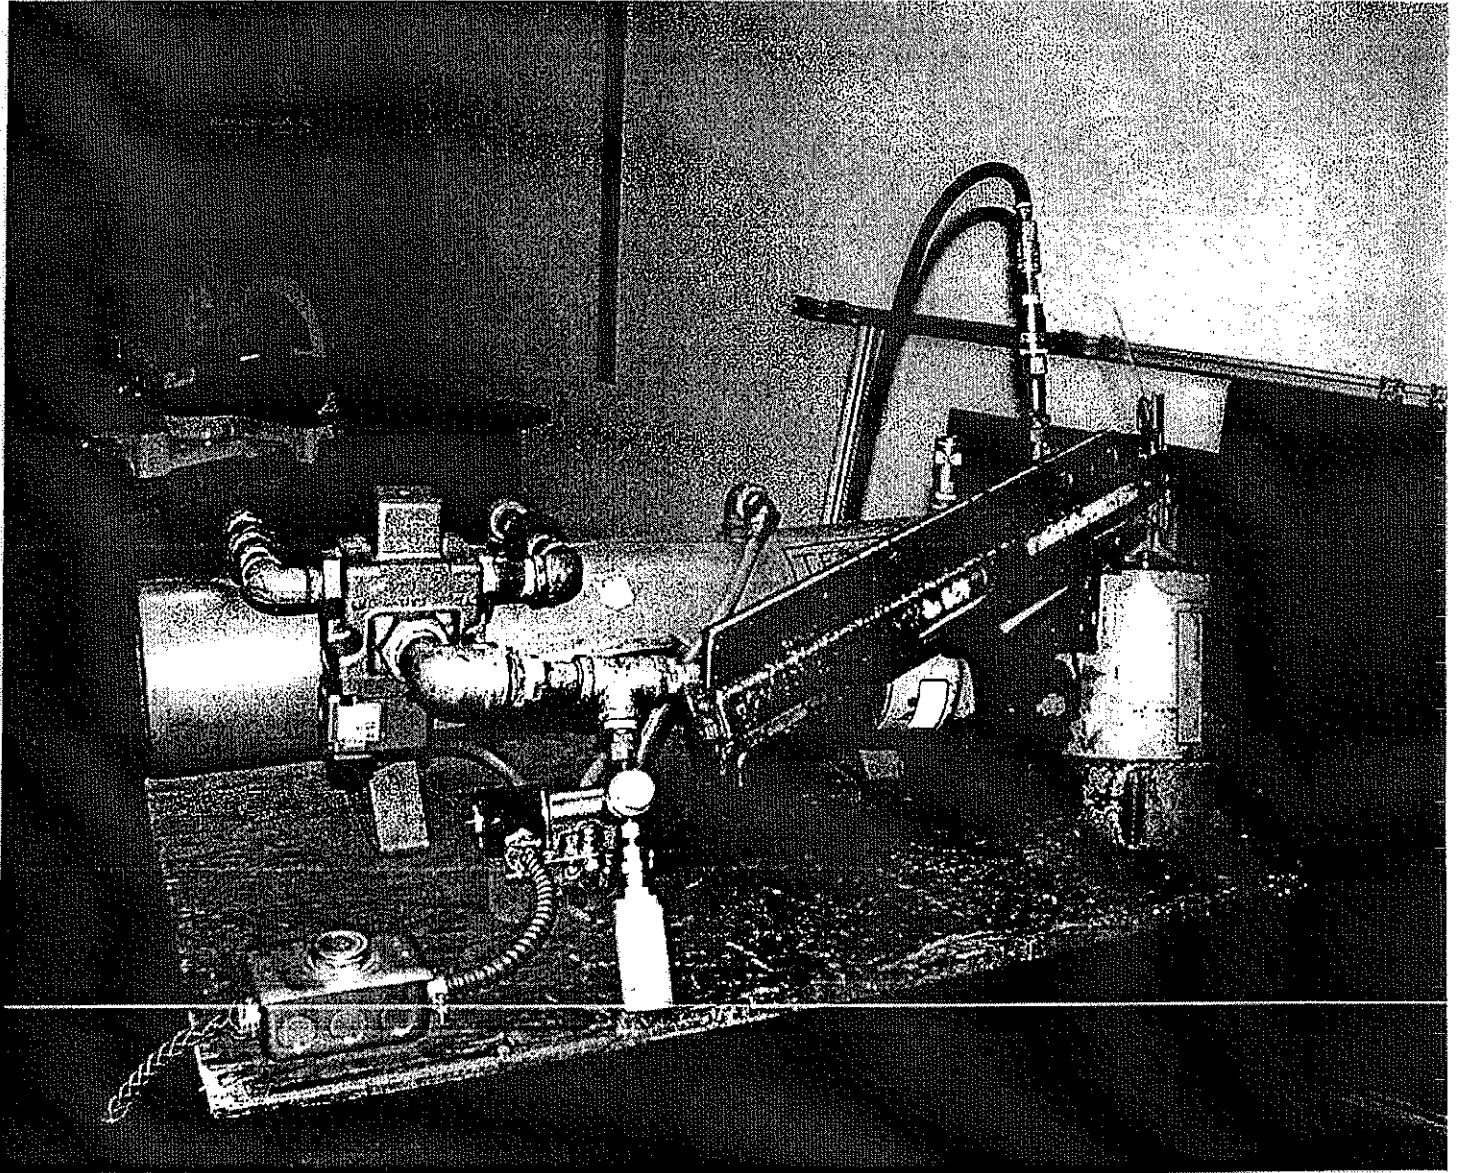
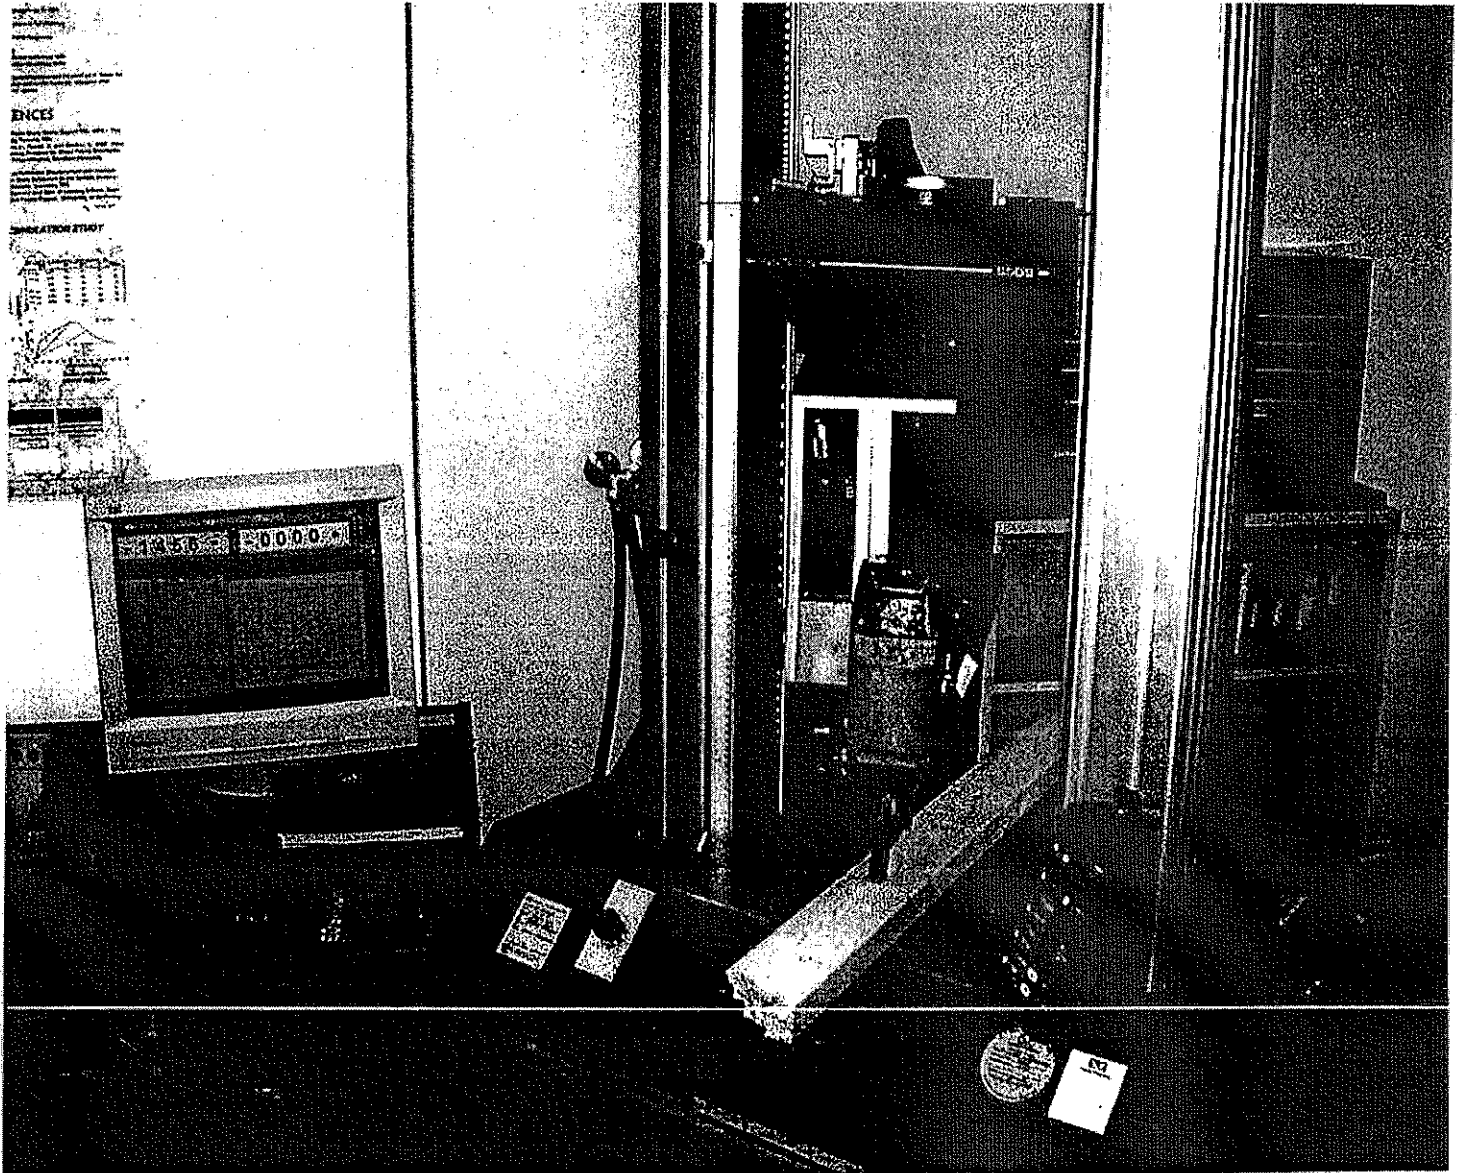
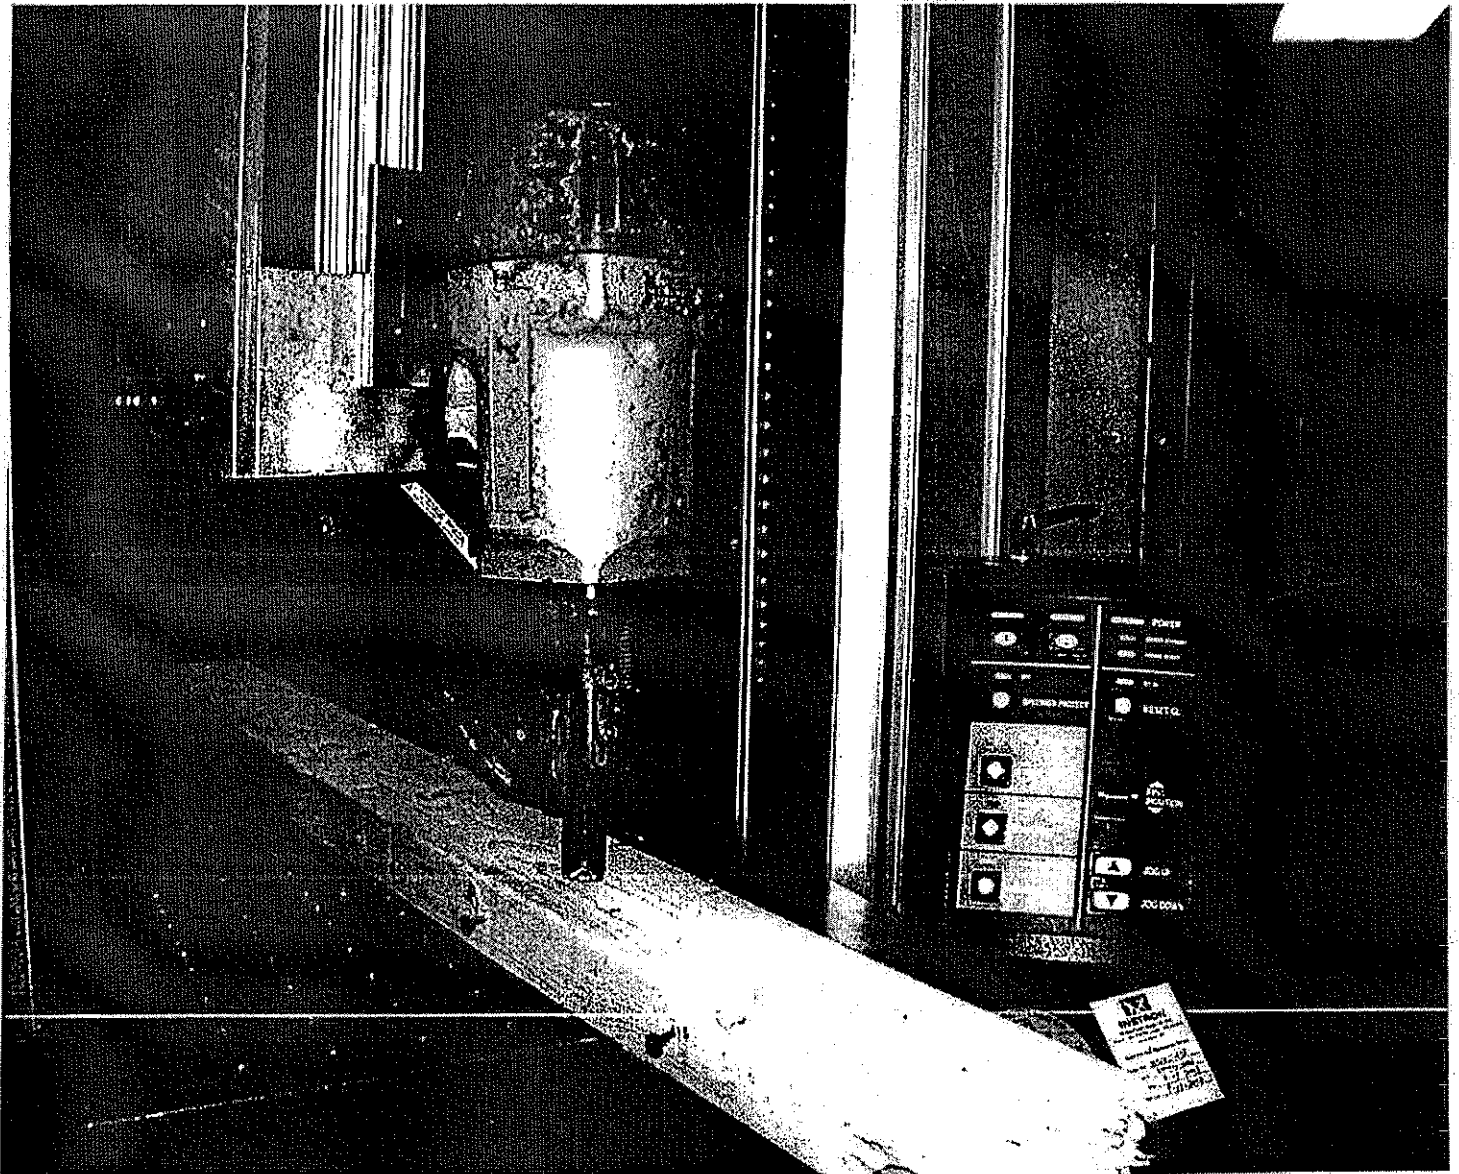
- 2). The tool appears to be mechanically complete.
- 3). The tool was received with an air fitting. The 3/8" light fitting will be used for testing.
- 4). The tool appears to have had a good amount of use.

- 5). A large amount of paint has been worn off the tool in various places, but doesn't appear to effect functionality.
- 6).The original warning stickers on the left side of the magazine are peeled and scraped from the tool, from what appears to be normal usage, and are 0% intact or legible.

- 7). The warning sticker on top of the magazine is about 90 % intact, and legible.
- 8). There is what appears to be an oily sawdust over some of the nose area, and right side of the magazine. This does not appear to affect functionality.

- 9). The tool is equipped with a contact trip trigger.
- 10). The rubber handle is intact, but has rips and holes in it in various places. The handle does not rotate on the tool.

- 11). The tool has a sticker on it that reads: Exhibit, Beijar 2, 4-27-04ev
- 12). The piston ring/cylinder is worn to the point where the driver will settle to the bottom of the cylinder under its own weight when the tool is upright.
